Combination of post-earthquake LiDAR data and satellite imagery for buildings damage detection

Niloofer Khodaverdi Zahraee¹, Heidar Rastiveis^{1*}, Arash Jouybari²

¹ Department of Photogrammetry and Remote Sensing, School of Surveying and Geospatial Engineering, University of Tehran, Iran

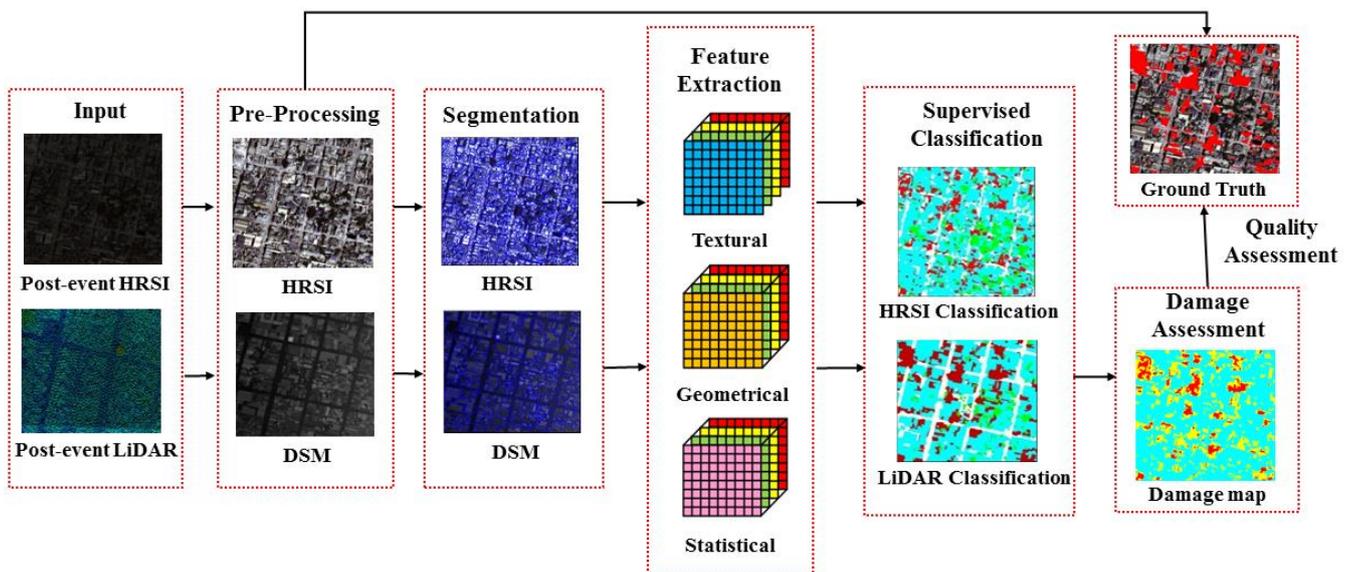
Figure 1. Flowchart of the proposed method for buildings damage detection after an earthquake, based on the combination of LiDAR data and high-resolution satellite imagery

The flowchart of the proposed method is summarized in Figure 1. As shown in this figure, in order to prepare the input data for building damage detection, the acquired LiDAR data and high-resolution satellite imagery (HRSI) of the post-earthquake are pre-processed and analyzed. Then, both of them are divided into several homogeneous segments using the multi-resolution segmentation technique. After that, two segmented datasets are classified based on the appropriate features and selected training samples. Finally, the classification results are compared, and building damage map is achieved in three classes of “Surely Damaged” and “Probably Damaged”, and “Undamaged”.

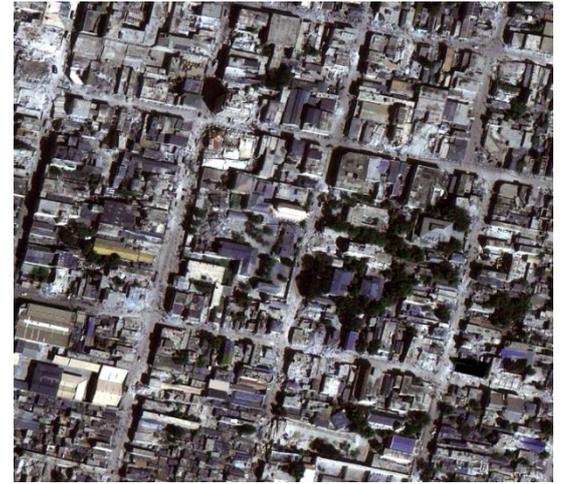
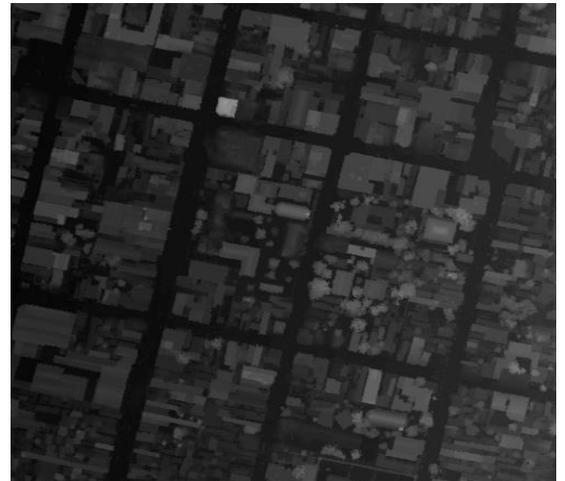
Figure 2. The selected area from the dataset as a test area. a) Post-event HRSI. b) Post-event LiDAR DSM

The study area is located in Port-au-Prince, city, Haiti, which was damaged by a catastrophic earthquake on January 12th, 2010. In this study, Worldview II satellite imagery and LiDAR DSM acquired on January 16th 2011 are used to evaluate the proposed method. The satellite image consists of four multi-spectral bands with a resolution of 2 m and one high-resolution panchromatic band with 0.5 m resolution. Four high-resolution colored bands are used in this algorithm, through integrating the multi-spectral and panchromatic bands. From the dataset, 1 km² study area equal to 1000×1000 pixels in the HRSI and 500×500 pixels in the DSM were selected, which are depicted in Figure 2.

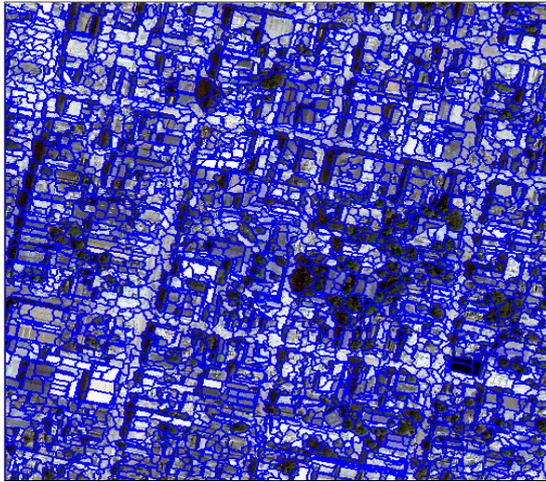
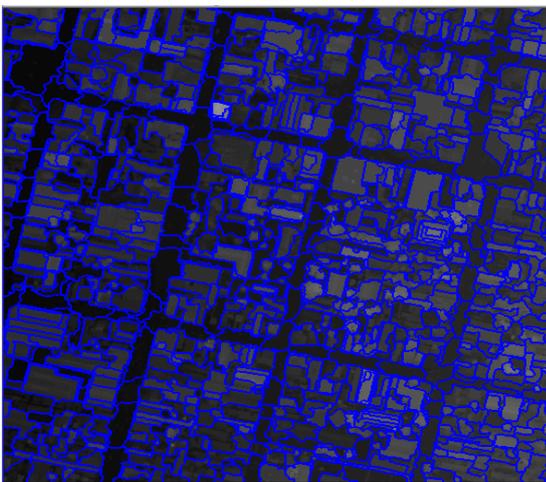
Figure 3. Extracted image-objects on post-earthquake image and DSM, through multi-resolution segmentation algorithm. a) Post-event image. b) LiDAR DSM.

After data pre-processing, segmentation of both images was performed through multi-resolution segmentation algorithm in eCognition Developer 9. In this case, the most important parameters including scale, shape, and compactness were considered to 17, 0.4, and 0.7 for the post-event image, and 20, 0.3, and 0.7 for the DSM. The results of this step for both image and DSM are shown in Figure 3. As seen, the number of obtained image objects from DSM is more than the segments on the HRSI.

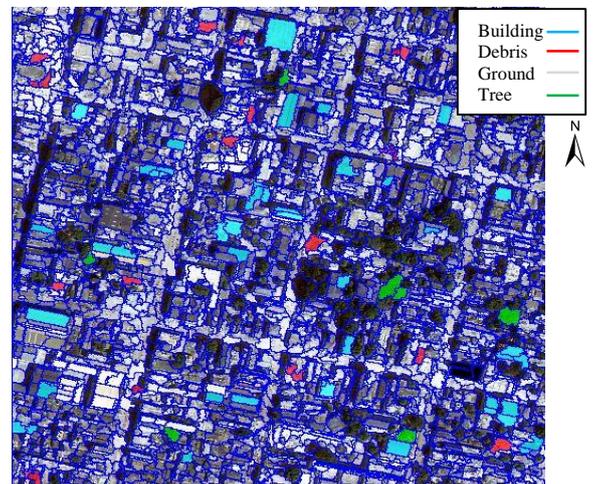
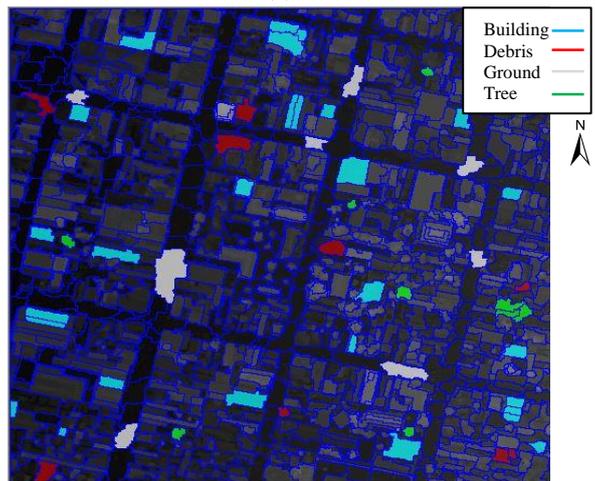
Figure 4. Selected samples on the post-event HRSI and DSM. a) Training data on the post-event HRSI. b) Training data on the DSM.

In the following, the selected image-objects for training the classification algorithm are shown in Figure 4. This figure demonstrates the total number of training samples, including the “Building,” “Debris,” “Tree,” and “Ground” polygons, which manually selected from the study area.

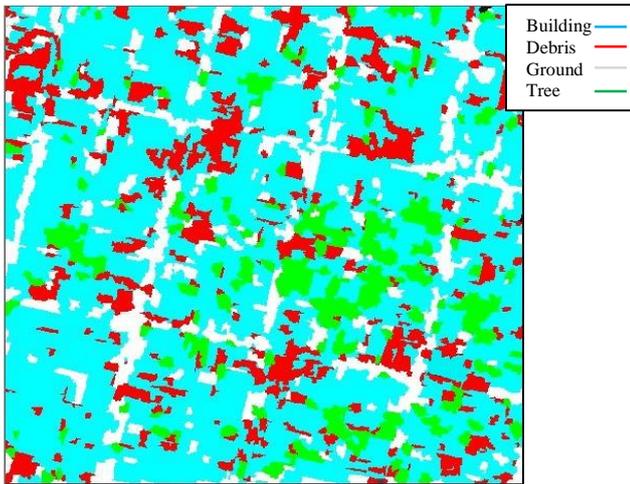
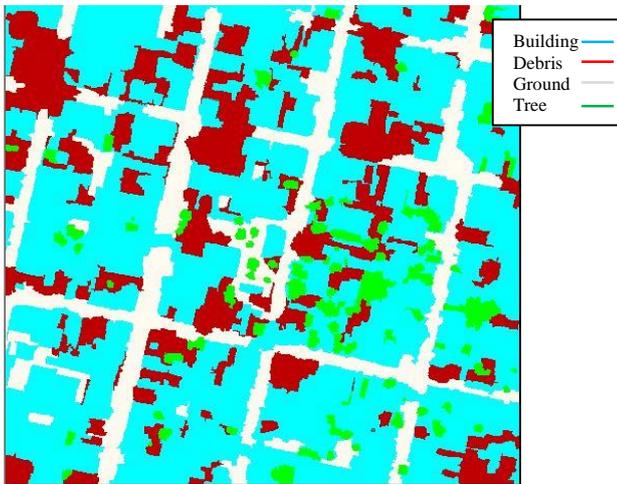
Figure 5. The Classified maps using the K-NN method. (a) The post-event HRSI. (b) The LiDAR DSM.

From Figure 5, it can be observed that completely eroded buildings with healthy roofs are well detected by the DSM data and could not be detected by satellite image. In contrast, the debris deployed on the road could not be detected by DSM, while the satellite image has easily recognized it. Also, most of the trees and grounds have been detected with high accuracy through the LiDAR data, while in some cases, satellite image has wrongly classified the ground as a building, and the shadow of a tree as a tree.

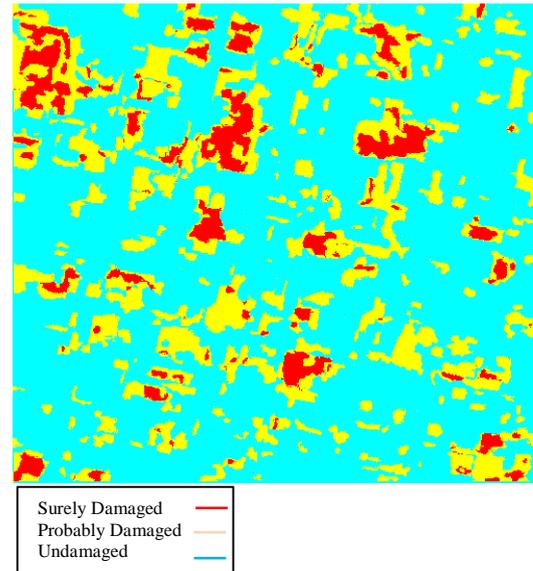
Figure 6. The result of combining the classification results of LiDAR-based DSM and post-event HRSI.

Generally, using only LiDAR or image cannot be an accurate result for building damage detection. Dividing the building damage areas into three classes of “Surely Damaged,” “Probably Damaged,” and “Undamaged” through combination process can be an appropriate way to determine where the first responders and rescue team should be sent and how to prioritize their efforts. In this way, relief will first be carried out in areas known as “Surely Damaged” by this algorithm. The integrating results of two classified images in three classes of “Surely Damaged,” “Probably Damaged,” and “Undamaged” are shown in Figure 6.

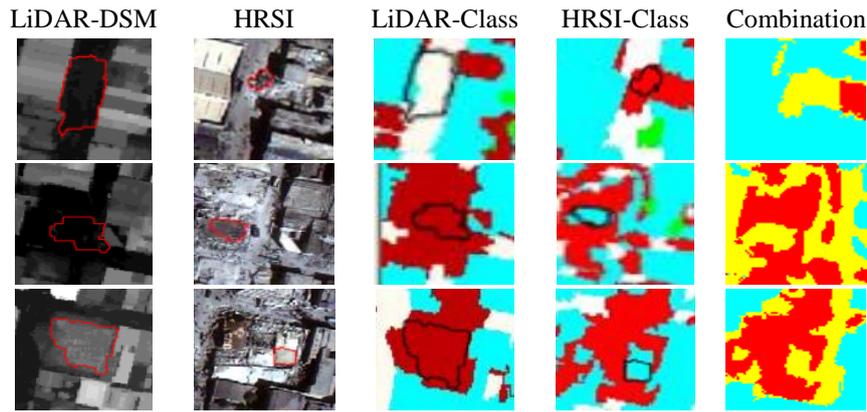
Figure 7. The result of the three segments in the classification step for both datasets. The five columns (left to right) include: (1) selected area on post-event LiDAR-DSM; (2) selected area on post-event image; (3) classification result based on LiDAR DSM; (4) Classification result based on satellite image; (5) building damage map by combining the classification results.

The result of the three segments in the classification step for both datasets are shown in Figure 7. As shown, in samples 2 and 3, the eroded buildings with healthy roofs are well detected by the DSM data while they could not be detected by satellite images. Conversely, from Section 1, the debris deployed on the road is not detectable by the DSM data while the satellite image has easily recognized it. These show the integration necessity to achieve more accurate results.
