## Developing Performance Levels for Concrete Bridge Bents with a Focus on the Joint Region

**ABSTRACT:** Bridges are critical highway structures, and damage to them can result in the loss of vital lifelines. Many bridges reaching the end of their expected lifespans should have their seismic performance evaluated immediately. The study utilized a 1/3 scale model of two-column bridge bents developed within the last 20 years that split from the deck under cyclic loads. The purpose is to investigate seismic performance and define performance levels utilizing experimental observation. The damage estimates from previous studies for each performance level were reviewed and, where necessary, revised. Damage and performance levels for joints were estimated differently than for other components such as cap beams and columns, according to the findings. The present study proposes new performance levels including joint damage. The overall seismic performance of the concrete bridge bents revealed that the anticipated mechanisms did not occur, but that flexural hinges formed in the joint region rather than in the columns, as required by current codes.

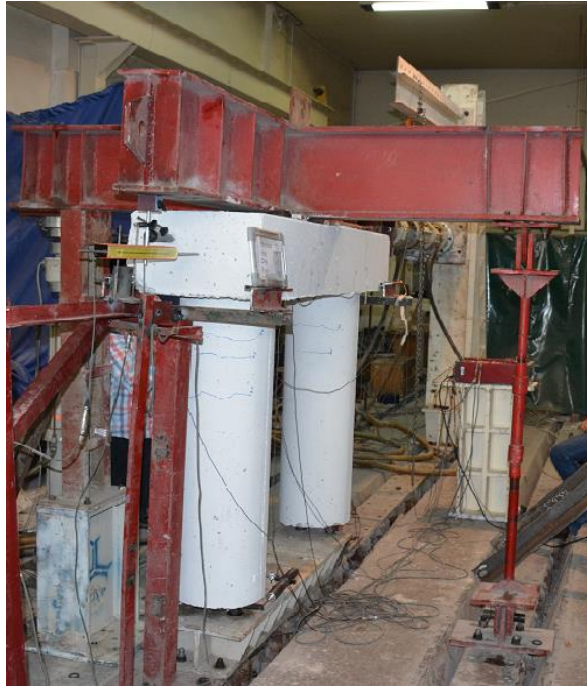
**Fig. 2.** Set up details

- A: Bridge pier bent specimen
- B: Steel frame for shear force jack and load cell installation
- C: Reliable holder for Jack
- D: Steel beam for specimen and rigid base connection
- E: Cross-shape beam for gravity load applying
- G: Cyclic loading jack
- H: Steel shear key for transmission shear load
- I: Neoprene plane for gravity load applying
- J: Hinge ends steel element

Figure 2 shows the components used to install and adjust the specimens as well as provide a rigid base. To achieve the desired hinged support conditions, two high-strength bolts were used at the column's end to connect the concrete bents to the rigid steel beam (Figure 3). Figures 4-7 show the locations of the gauges.

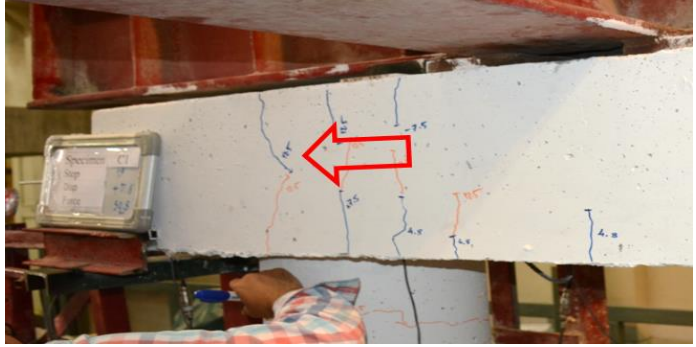
| Order | Damage type | Lateral displacement (%) | Figure |
|---|--|---|--|
| 1 | Capillary cracks and diagonal cracks of less than 2.3 mm in width | 0.73 | <p><b>Fig. 16.</b></p> |

As shown in Table 7, all damages observed in the components and joint region have been described in terms of relative displacement. The first cracks were discovered in the joint region at a relative displacement of 0.73 percent (capillary cracks and diagonal cracks of less than 2.3 mm in width). A diagonal crack exceeding 0.5 mm occurred at the right joint at a relative displacement of 1.83 percent. Strain penetration caused a crack opening greater than 1 mm at the left cold joint. At a relative displacement of 2.73 percent in the joint region, the diagonal cracks extended to more than 1 mm (Figures 16-19).

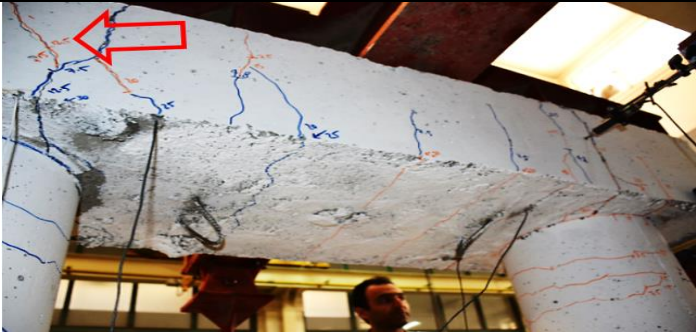
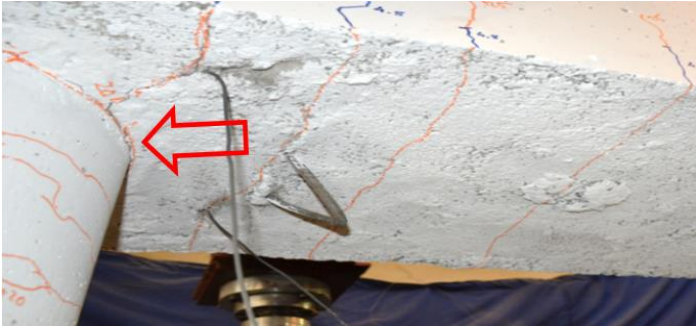
| Order | Damage type | Lateral displacement (%) | Figure |
|---|--|---|--|
| 2 | Diagonal crack exceeding 0.5 mm at eastern joint; diagonal crack exceeding 1 mm in width at left cold joint crack opening caused by strain penetration | 1.83 | <p><b>Fig. 17.</b></p> <p><b>Fig. 18.</b></p> |

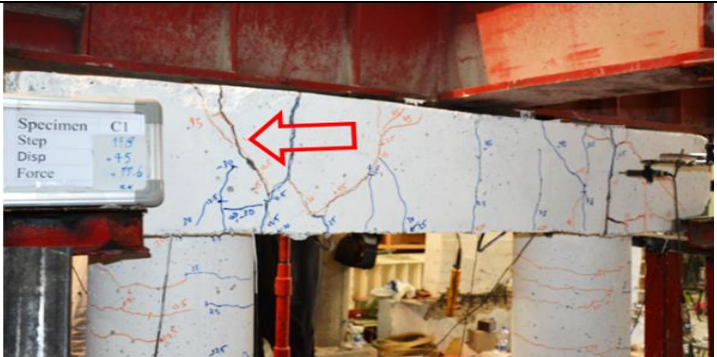
| Order | Damage type | Lateral displacement (%) | Figure |
|---|--|---|--|
| 3 | Extension of diagonal cracks exceeding 1 mm in length in joint region | 2.73 | <p><b>Fig. 19.</b></p> |

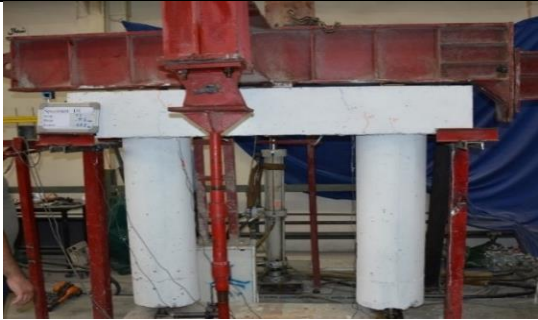
| Order | Damage type | Lateral displacement (%) | Figure |
|---|--|---|---|
| 1 | Capillary crack and diagonal crack of less than 2.3 mm in width. | 0.43 | <p><b>Fig. 20.</b></p> |

Table 8 shows the progression of damage in the joints of the SP-80 specimen in terms of relative displacement, which is illustrated in Figures 20-24. At a relative displacement of 0.43 percent, the first crack appeared (capillary and diagonal cracks of less than 2.3 mm in width). A cold joint capillary crack appeared in the interior surface of the left connection at 0.92 percent displacement, and a cold joint capillary crack appeared in the exterior surface of the eastern joint at 0.92 percent displacement.

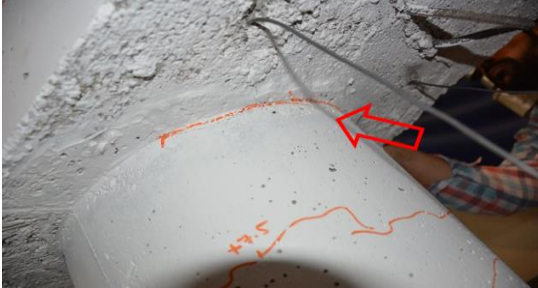
| Order | Damage type | Lateral displacement (%) | Figure |
|---|--|---|---|
| 2 | Cold joint capillary crack in left joint | 0.92 | <p><b>Fig. 21.</b></p> |

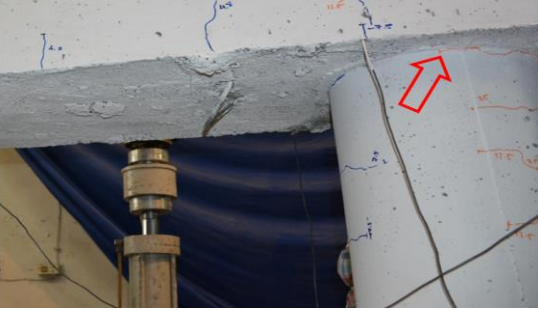
| Order | Damage type | Lateral displacement (%) | Figure |
|---|--|---|---|
| 3 | Cold joint capillary crack in eastern joint | 0.93 | <p><b>Fig. 22.</b></p> |

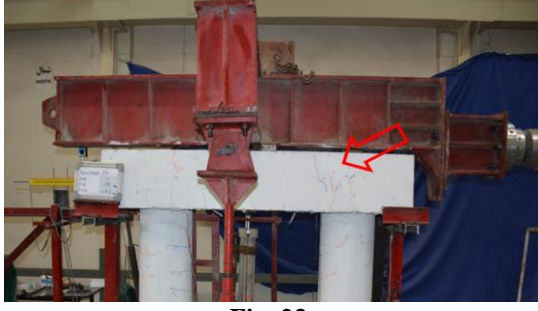
| Order | Damage type | Lateral displacement (%) | Figure |
|---|--|---|---|
| 4 | Diagonal cracks exceeding 0.5 mm observed in left joint | 1.82 | <p><b>Fig. 23.</b></p> |

Diagonal cracks of greater than 0.5 mm were observed at a relative displacement of 1.82% in the left joint. At this displacement, the cold joint crack opened wider than 1

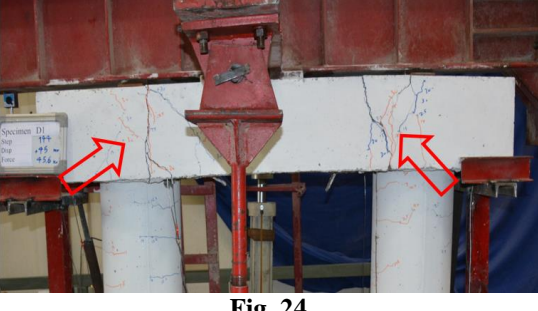
| Order | Damage type | Lateral displacement (%) | Figure |
|---|--|---|---|
| 5 | Crack width in eastern and left joints exceeded 2 mm. | 3.64 | <p><b>Fig. 24.</b></p> |

mm. At a relative displacement of 3.64%, the width of the cracks in the eastern and left joints exceeded 2 mm.

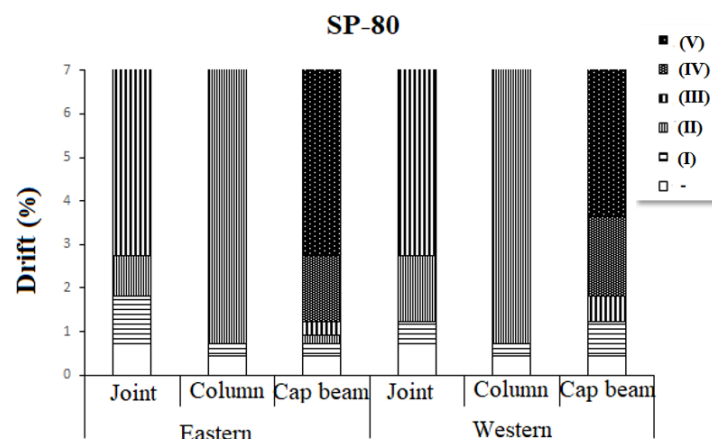
**Fig. 25.** Performance of components

Figure 25 depicts the performance of the specimen SP-80 components in relation to drift. It can be seen that the damage trend and performance level for the joint were level III, level V for the cap beam, and level II for the column. This means that even if the joint is at level III, the column remains at level II. Despite the fact that the joint and cap beam have reached performance level V, the column has not been seriously damaged. This is in direct conflict with the seismic design criteria.

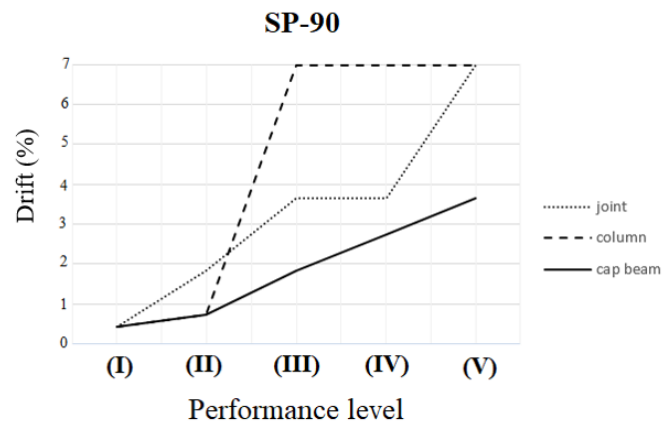
Fig. 29. Comparison of performance of components in SP-90

Figures 29 and 30 represent the minimum drift values for each of the five performance levels. The joint and cap beam performance in specimen SP-90 can be seen to be completely rejected. The cap beam was damaged much earlier than the column,

and the column was only slightly damaged before the joint was damaged. The column eventually reached performance level II, and no damage matching levels III to V were observed. The joint performance, on the other hand, reached level IV.

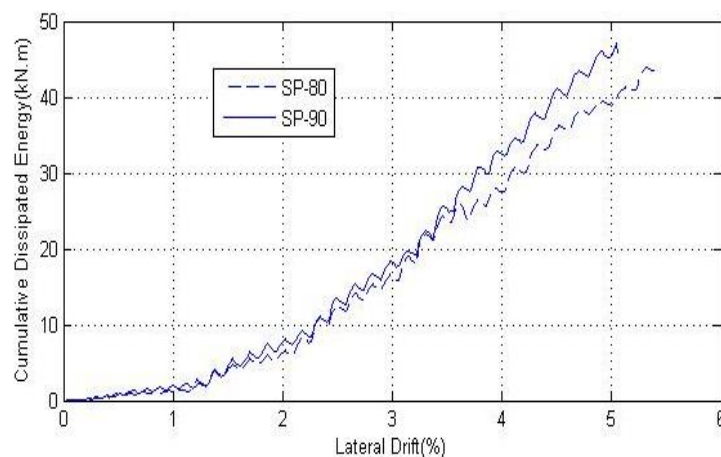
Fig. 31. Increase trend of cumulative dissipated energy

The ability to dissipate energy is the most important parameter in structural seismic response. Figure 31 shows the increasing trend of cumulative dissipated energy by specimens. The specimen show relatively low drifts range at the end of test. Hysteresis curves represented little ability to absorbed and dissipate energy. Many reasons can be cited, including the defect of

structural details in older codes, the lack of a desirable failure mechanism, and the early occurrence of damage levels in the beams and connection region. A significant and significant result is the need to strengthen for the tested bents. As a result, more of the structure's capacity can be used for energy dissipation, and more deformation can occur.
